Consultant: DRUK GREEN CONSULTANCY		Owner: DEPARTMENT OF ENERGY MINISTRY OF ENERGY AND NATURAL RESOURCES	
Date	August 2023	Revised date	
Designed	C.Wangdi	Verified	T.Dorjee
Reviewed	C.Wangdi	Approved	C.Tenzin
Drawn	C.Wangchuk	Scale	AS SHOWN
THIS DRAWING IS MEANT FOR FSR NOT TO BE USED FOR CONSTRUCTION.		Project: 25 MW BEGANA INTEGRATED MULTIPURPOSE SMALL HYDROPOWER PROJECT THIMPHU, BHUTAN Title: GEOLOGICAL MAP OF HRP ALIGNMENT Drawing No. BIMSHP-GEO-2023-2	
Rev.	0

4. Project Geology and Geotechnical Assessment

DEPARTMENT OF ENERGY MINISTRY OF ENERGY AND NATURAL RESOURCES	
Date	August 2023	Revised date	
Designed	G.Gajmer	Verified	T.Dorjee
Reviewed	D.Singer	Approved	C.Tenzin
Drawn	G.Gajmer	Scale	AS SHOWN
THIS DRAWING IS MEANT FOR FSR NOT TO BE USED FOR CONSTRUCTION.			
Project:		25 MW BEGANA INTEGRATED MULTIPURPOSE SMALL HYDROPOWER PROJECT THIMPHU, BHUTAN	
Title:		TYPICAL CROSS SECTIONS OF HEADRACE PIPE	
Drawing No.:		BIMSHIP-CD-HRP-2023-03	
Rev.	0

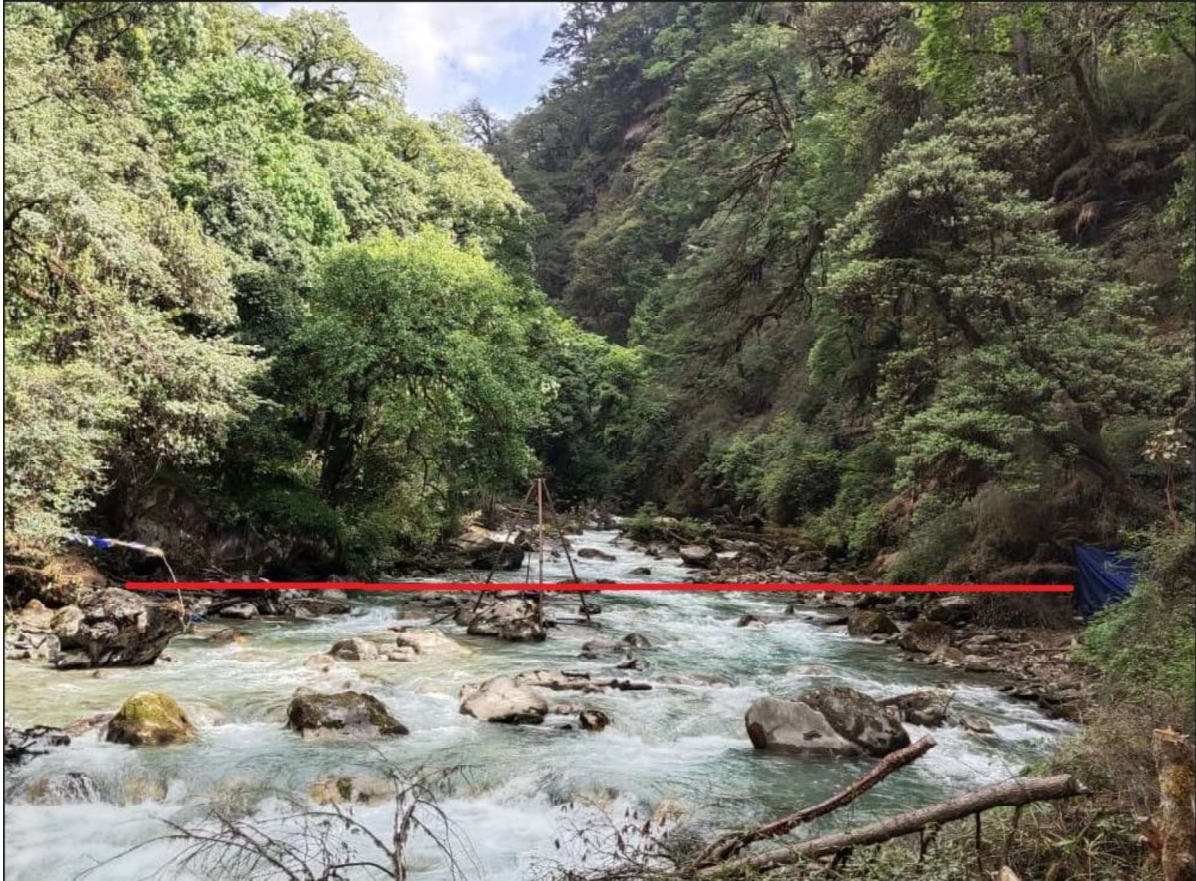
Photo 4-1: Location of weir axis

On the left of the weir axis and intake area, fair and up stream of weir axis, rock mass predominantly comprising of medium to fine grained, slightly to moderately weathered, light grey biotite gneiss with occasional intrusions of pegmatite and quartz band is observed by three set of discontinuities; The characteristic features of major discontinuities are given in **Table 4-1**, **Figure 4-1** and **Photo 4-1** and **Photo 4-2**.

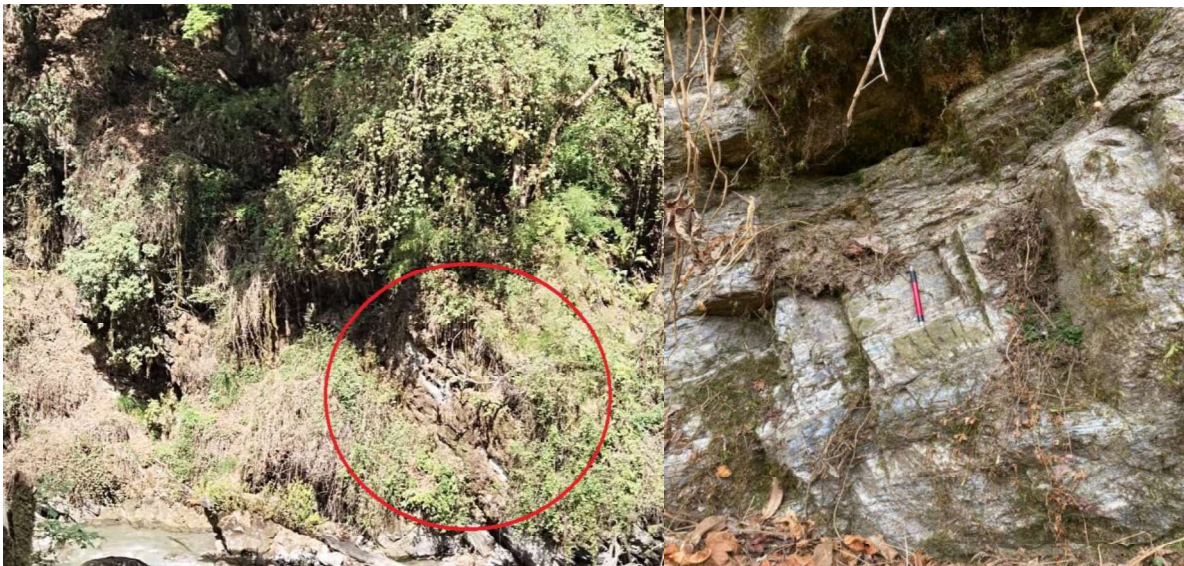
Photo 4-2: Rock exposure at right bank 10m d/s of weir axis (left) and at intake area (right)

On the right bank of the Weir axis, it is covered with colluvium from 1m to 10m thick on top followed by alluvial materials. Colluvium mainly consist of soil, boulders and decomposed plants and approximately 10m downstream of the weir axis exposure of Biotite gneiss with quartz and pegmatite intrusion at some stretches with discontinuities, foliation- 56°/269°, tightly, closely spaced, Joint (J1) 57°/068° and 54°/096° low persistence, slightly open at place, slightly to moderately weathered are observed. About 5m upstream of weir axis, colluvium deposit is observed. Prima facie, looking at trees at the base near the riverbed, the right abutment seems to be stable.

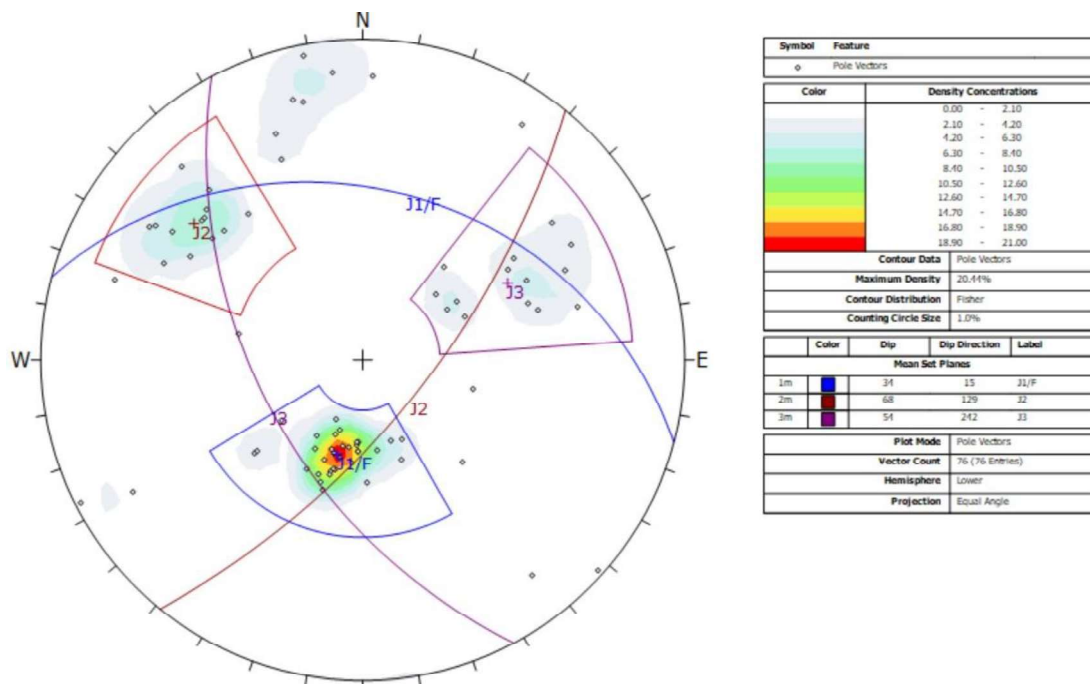
Figure 4-1: Stereographic projection of discontinuities at Weir, Intake area and desilting chamber

Biotite Gneiss	Joint Characteristics						
	Joint Type	Orientation	Joint Surface	Weathering	Aperture (mm)	Persistence (m)	Spacing (cm)
J1 (foliation)	20-46°/013-019°	Rough/planer	Un-weathered	<0.1-1	>10	10-40	None
J2	58-86°/123°-147°	Slightly Rough/planer	Un-weathered	<0.1-1	10-20	60-100	Roots of tree
J3	50-86°/215-256°	Slightly Rough/planer	Un-weathered	<0.1-1	5-10	20-30	None

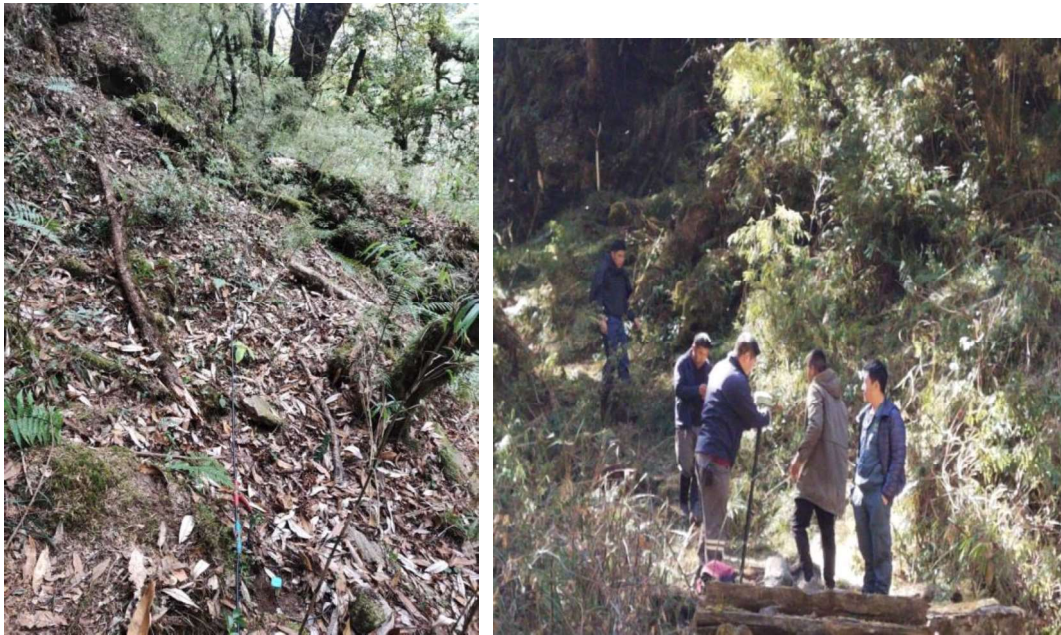
Photo 4-3: Geophysical Profile layout and geophone location collected using RTK

In-order to study the foundation and the rock line, geophysical profiles were carried out; five profile length of 115 m each of SRT has been carried out at intake and desilter area as detailed in **Table 3-2** and **Photo 4-3.** The results of SRT profiles SRT-1, 2, 3, 4 & 5 which is aligned along the intake area till desilter area indicates presence of four contrasting layer with different seismic velocity with varying thickness as described in **Table 4-2.** Detailed report on Geophysical explorations is appended as **Appendix II.**

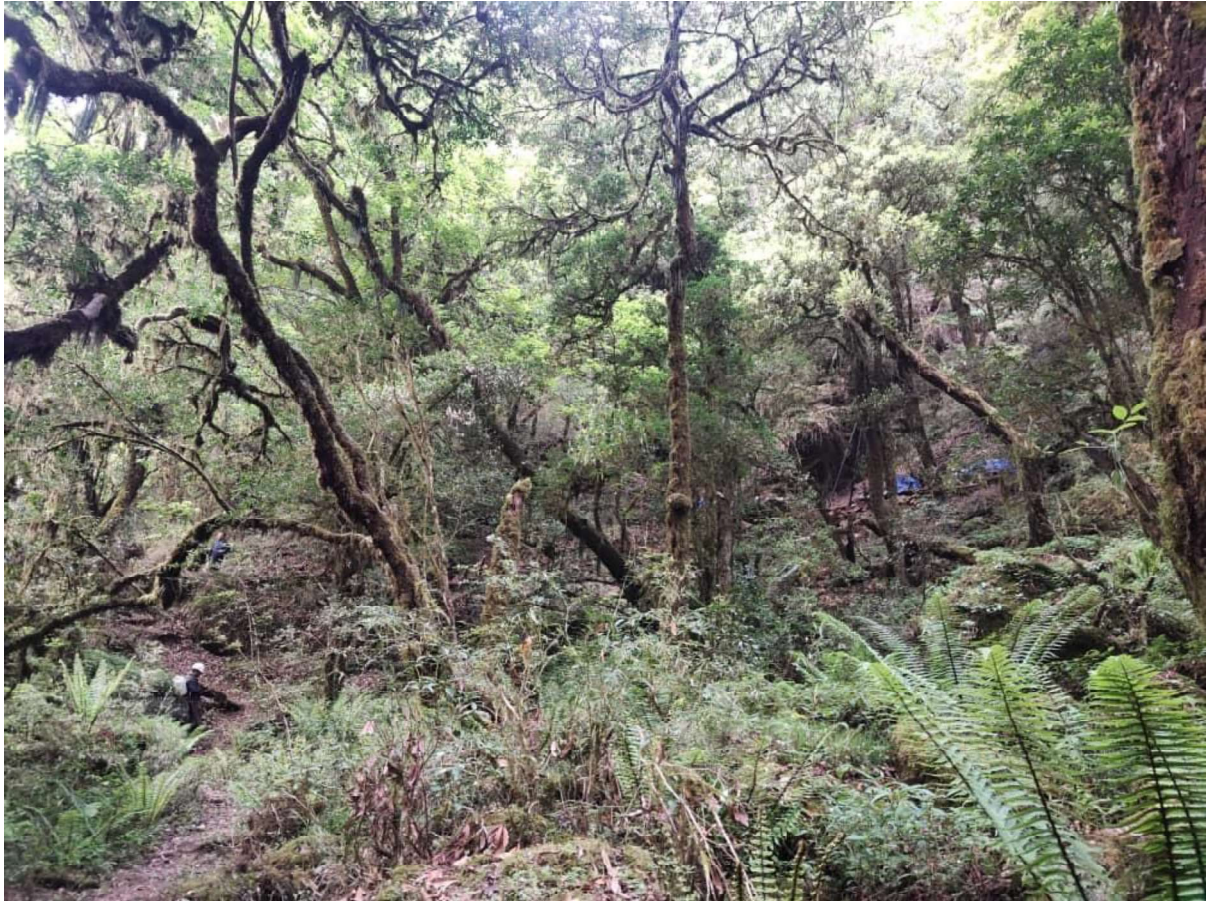
Photo 4-4: Desilter area covered with tree, bushes and boulders

The desilter area is placed on colluvial/alluvial deposit of about 15 m thick. The end part of the desilter is placed on adjacent exposure of biotite gneiss and on talus deposit of angular to sub angular deposit of boulders and alluvium of river borne deposits. Traverse along the desilter and the initial span of the surface HRP from the desilter till the inlet portal has been met with colluvial

deposit of dark grey, coarsed grained soil/sandy soil with few angular gravel and boulders of size 250-600 mm, cobbles and pebbles and no water table observed, **Photo 4-4 and Photo 4-5.**

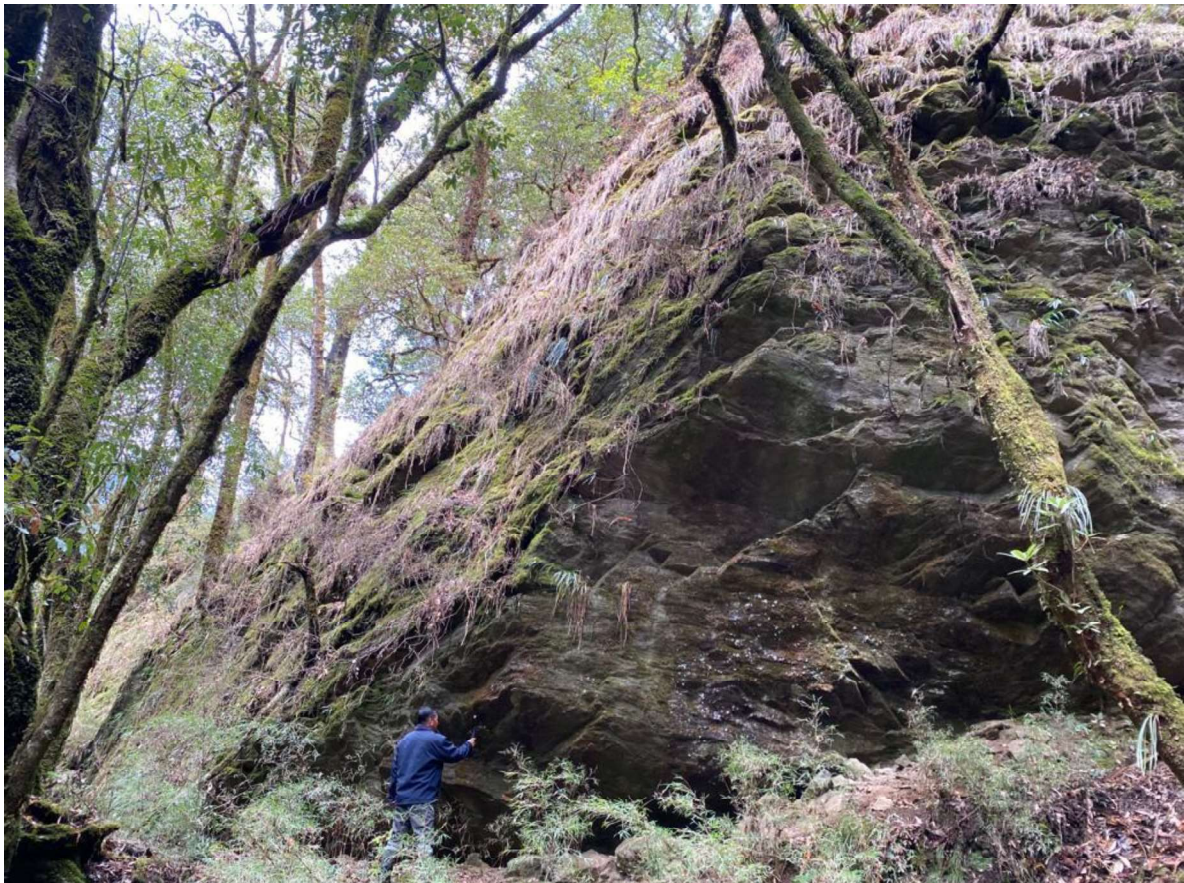
Photo 4-5: Exposure at Desilter area

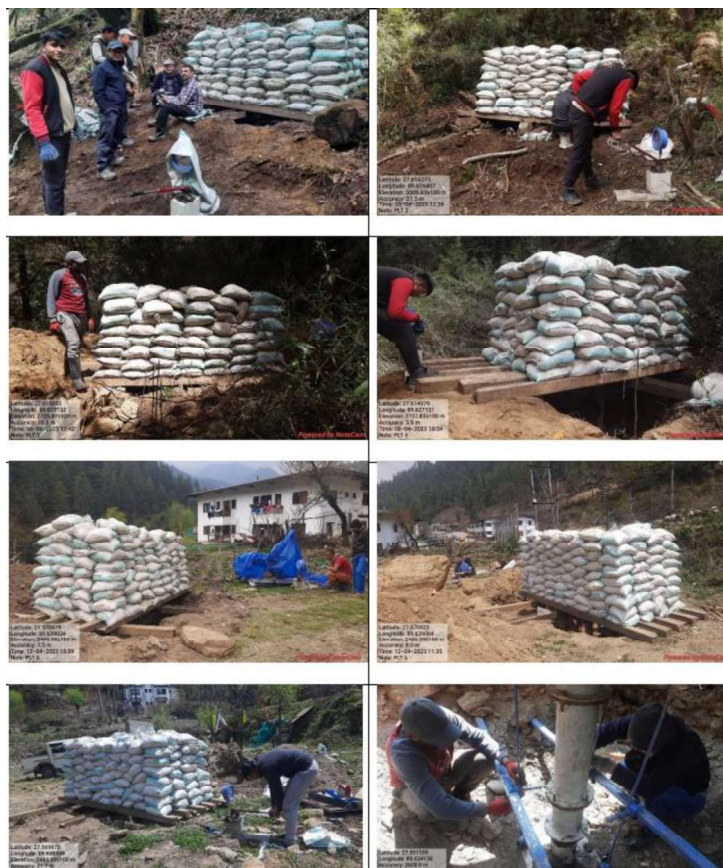
Photo 4-6: PLT set up at different locations

In situ plate load test (PLT) were also carried out to determine the safe bearing capacity and associated laboratory test were also conducted, **Photo 4-6**. The safety bearing capacity (SBC) at PLT-01 at right bank of weir axis for foundation width 2 m, 4 m, 6 m and 8 m is 200 kN/m², 180 kN/m², 170 kN/m² and 156 kN/m² respectively with average cumulative settlement of 8.56 mm; PLT-02 at left bank of weir axis for foundation width 2 m, 4 m, 6 m and 8 m is 260 kN/m², 232 kN/m², 212 kN/m² and 204 kN/m² respectively with average cumulative settlement of 6.99 mm; PLT-03 and PLT-04 at desilter area computed SBC of 248 kN/m², 220 kN/m², 208 kN/m² and 196 kN/m² with average cumulative settlement of 5.97mm and 268 kN/m², 240 kN/m², 218 kN/m² and 204 kN/m² with average cumulative settlement of 5.72 mm for foundation width of 2, 4, 6 and 8 m respectively. The summarised resulted are tabulated above in **Table 3-5** and **Table 3-6** and detail report is attached as **Appendix IV**.

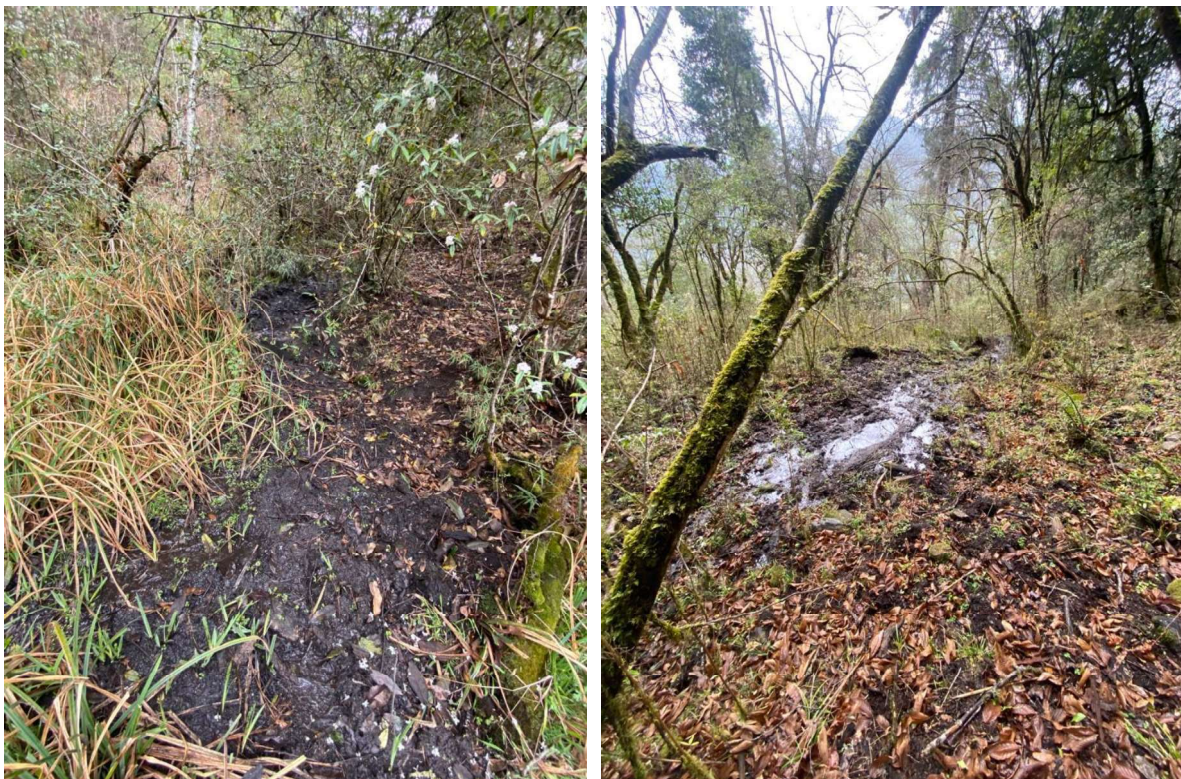
Photo 4-7: Marshy area along the HRP alignment

From RD 4,500 to 5,500 m of HRP alignment, the presence of marshy area was observed. The HRP alignment would be laid over colluvial deposit/marshy area. The thickness of colluvial deposit varies from 5 m to 25 m thick. The sub-surface features along HRP have been explored

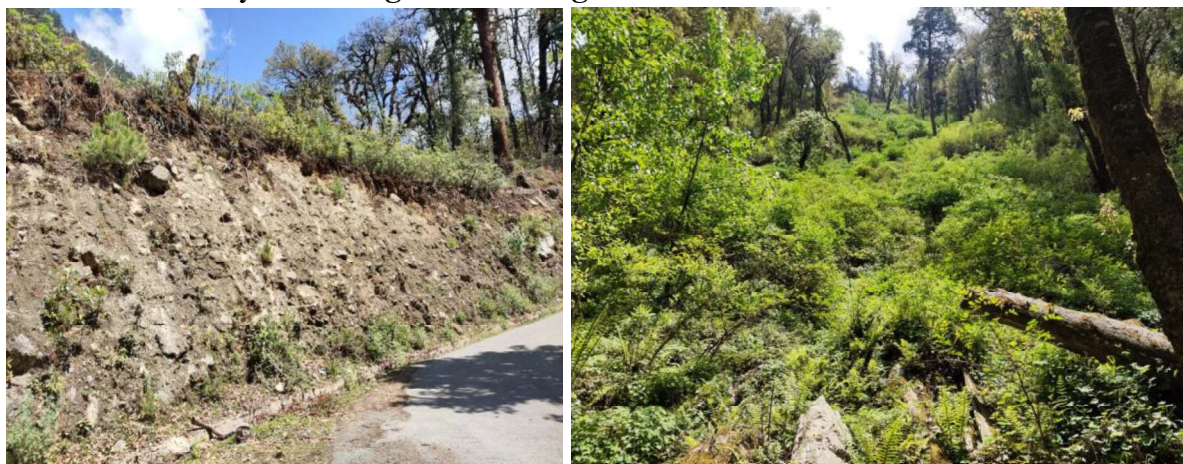
Photo 4-8: Alluvial deposit and vegetation cover along HRP alignment

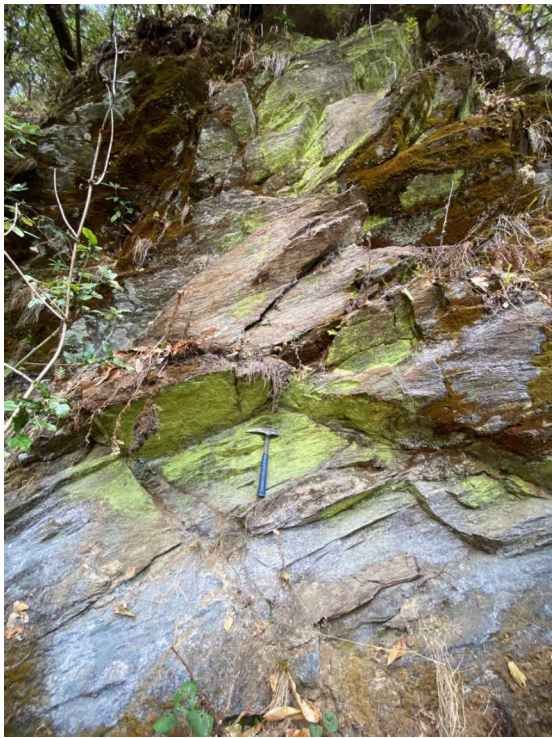
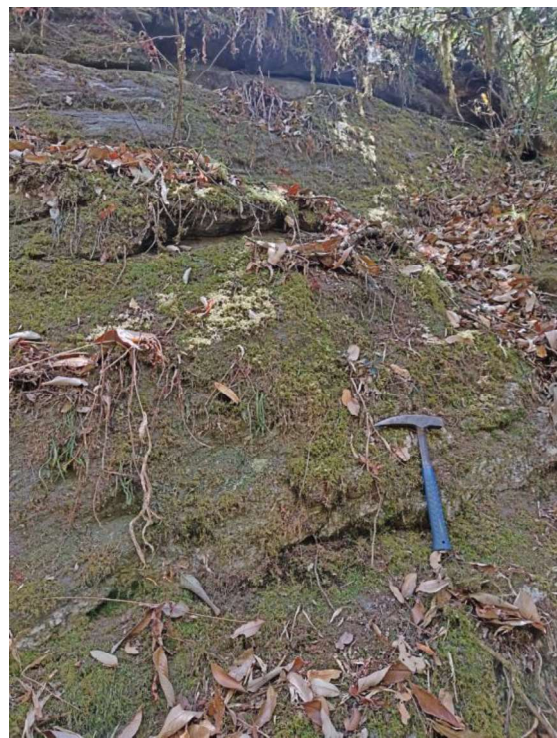
Photo 4-9: Exposure along the HRP alignment

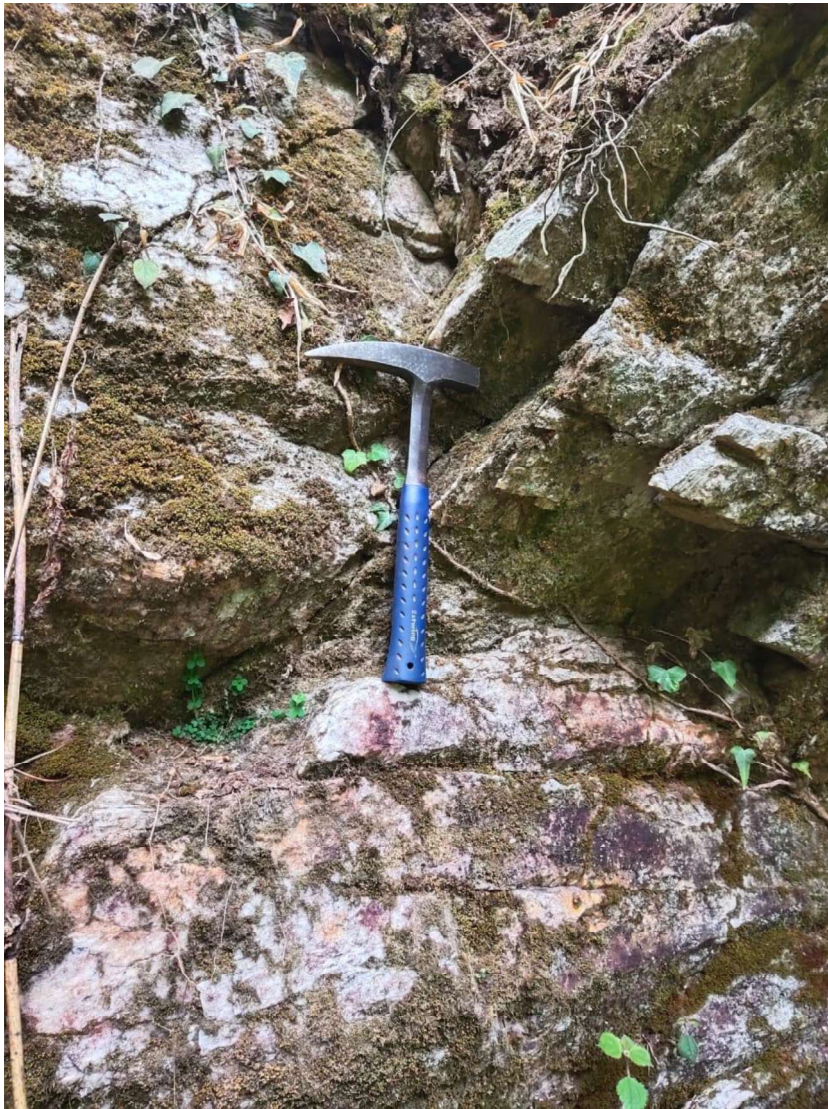
Photo 4-10: Quartzitic Gneiss exposure along HRP

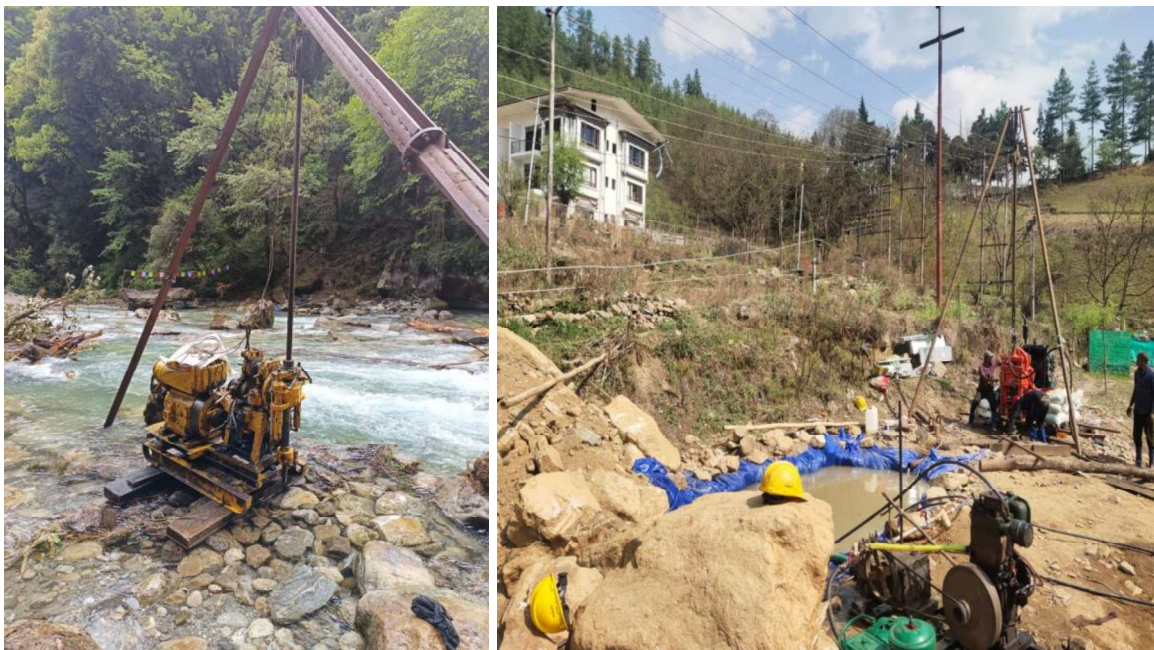
Photo 4-11: Core Drilling at Intake and Power House

Total of three (3) numbers of bore holes were drilled whereby two were drilled at the intake (BH-01 & BH-02) and one at the desilter area (BH-03). The summarized geological details of bore holes are presented in

Table 4-3, Photo 4-11 and the detailed drilling report will be attached as **Appendix III** after the completion of drilling works along with laboratory test results.

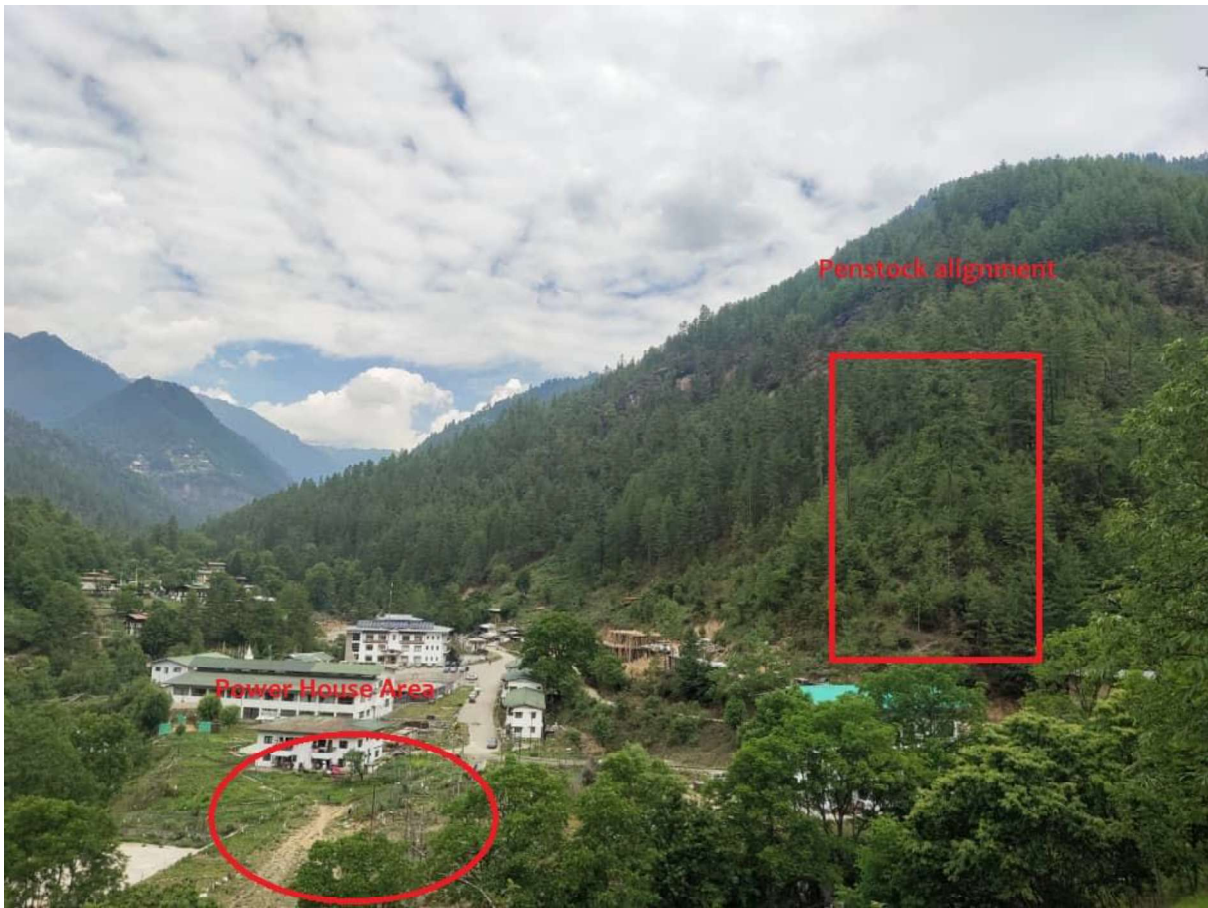
Photo 4-12: Penstock and Power House Locations

The proposed site for the power house complex, 39 m (L) x 20 m (B) x 26 m (H) is covered with 27 m to 28 m thick alluvial deposits comprising boulders, cobbles, gravels and silty sand, **Photo 4-12**. The power house area has been explored by two bore holes i.e. BH-09 & 10 where the geophysical profile SRT-09 has been conducted. The summary of geological logs is provided in **Table 4-8** and summary of interpretation of geophysical profile in **Table 4-9**. The site has also been examined by three no. of plate load test viz. PLT-05, PLT-06 and PLT-07. Safe bearing capacity and laboratory test results are tabulated in **Table 3-5** and **Table 3-6** respectively.

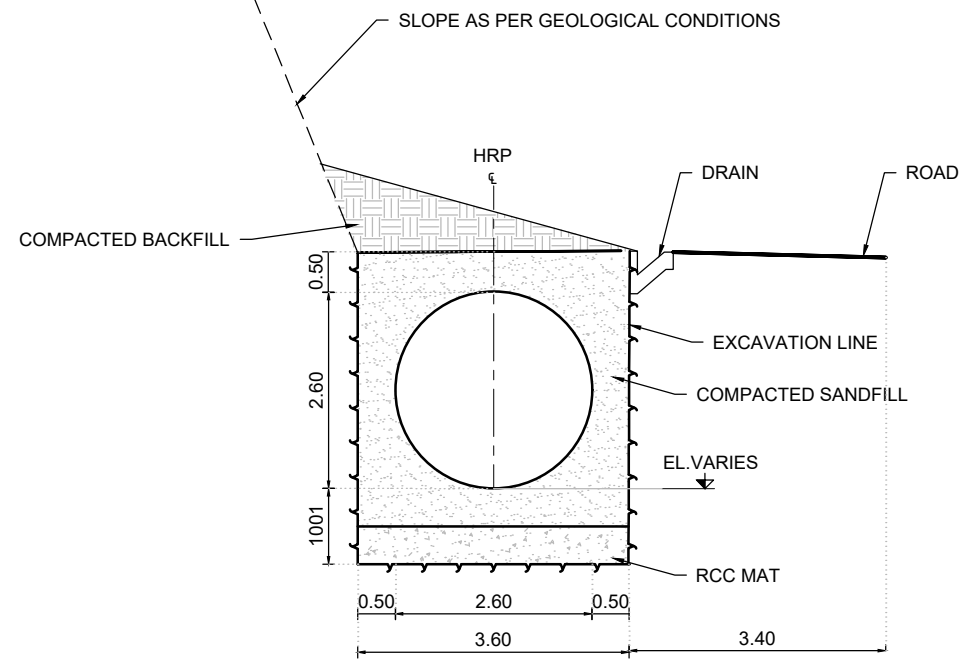
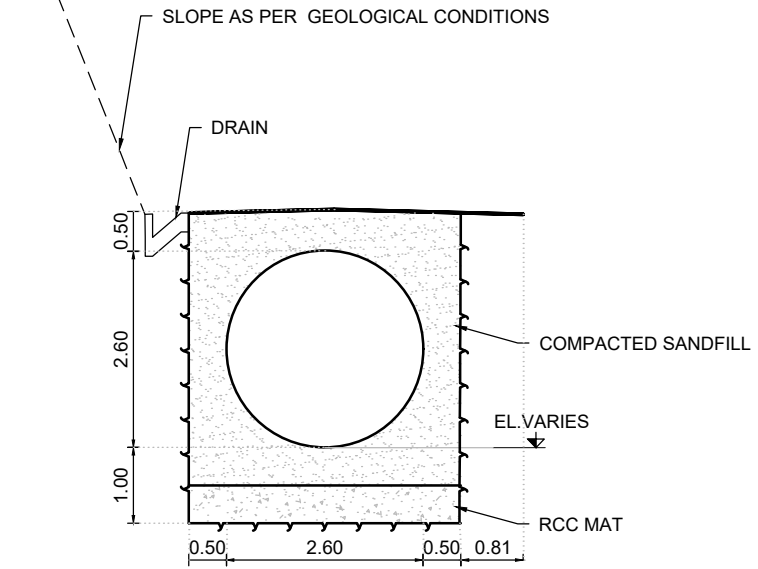
**TYPICAL SECTION OF TRENCHING OF HRP
SCALE 1: 100**

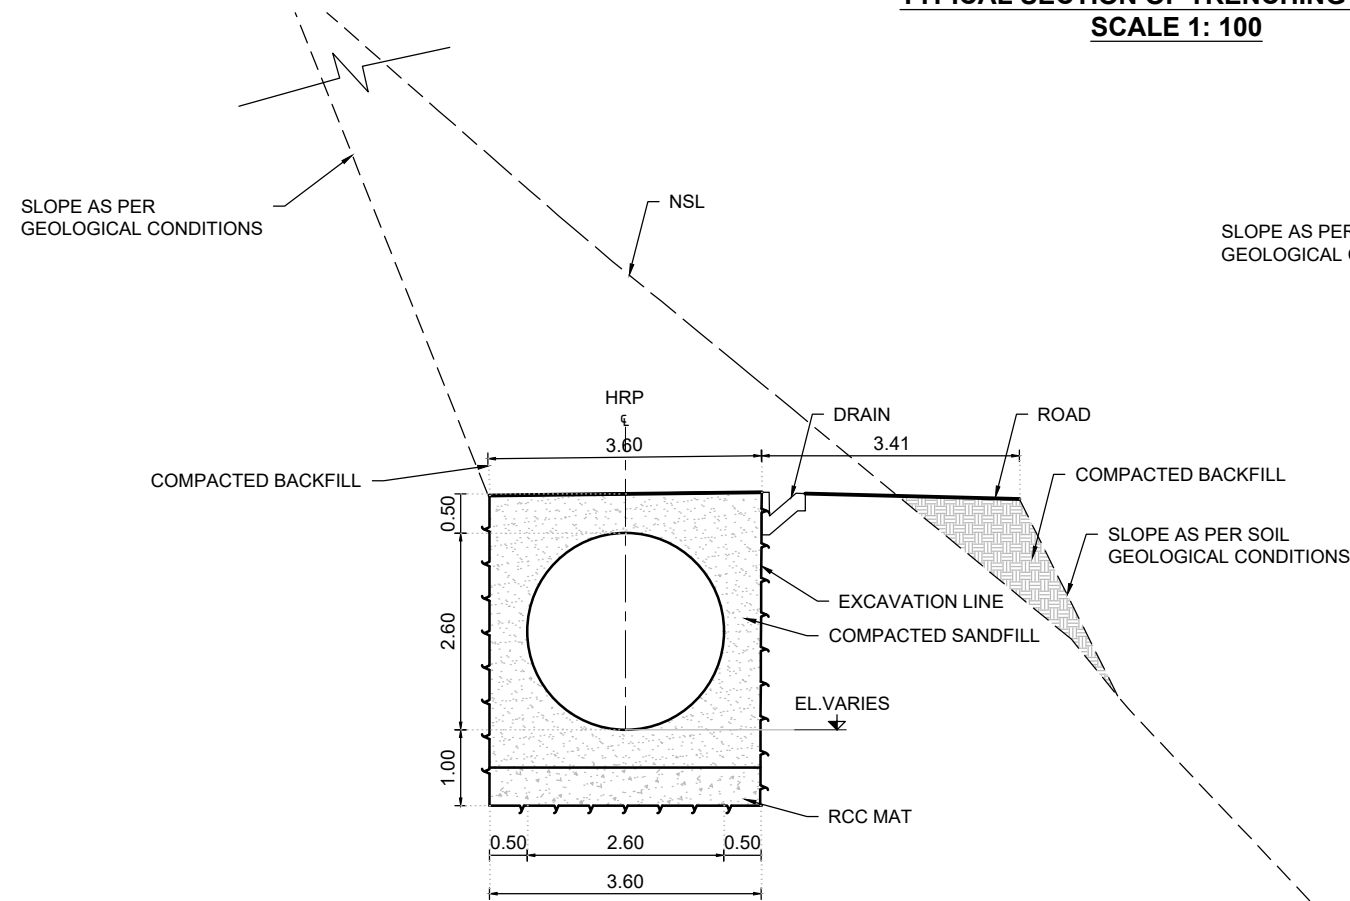
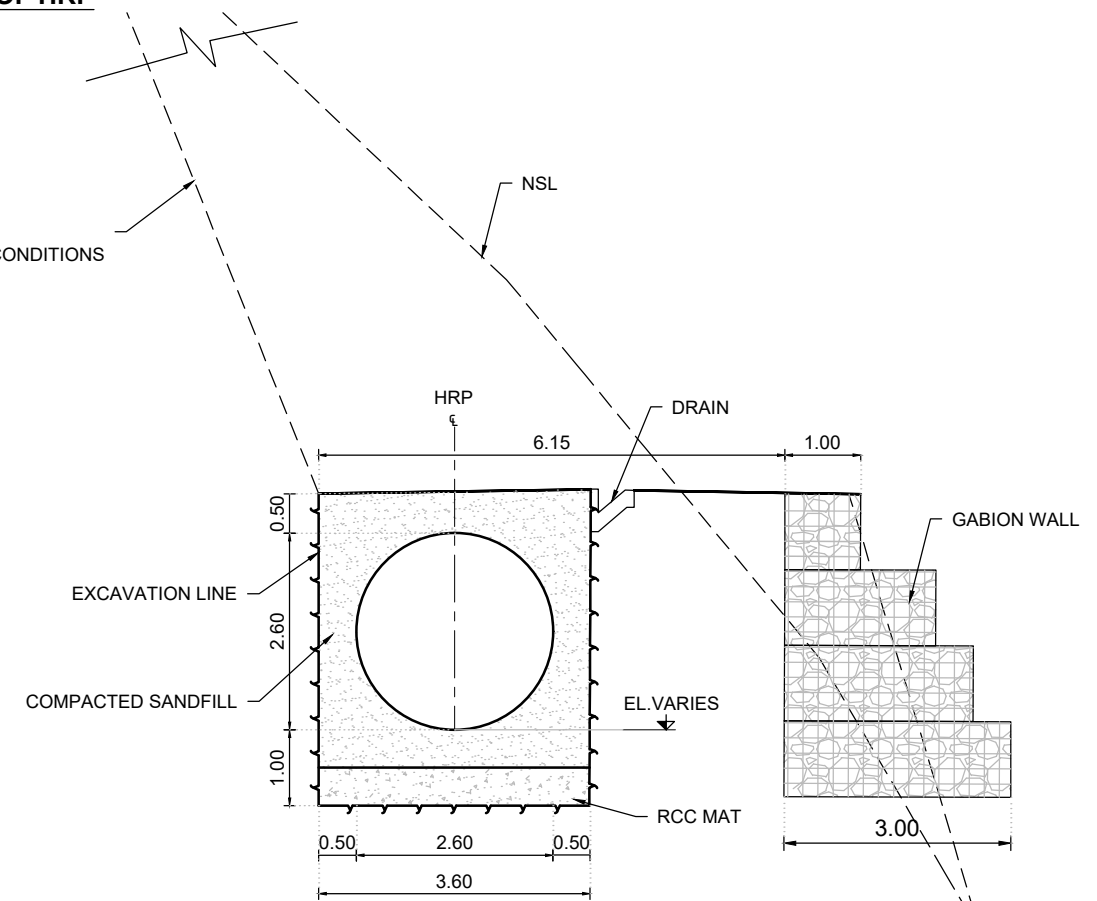
**TYPICAL SECTION OF ROAD WITH HRP
SCALE 1: 100**
